FIELD SERVICES, AEROADVANTAGE  
SERVICES, AND LEASE ENGINE

2X LM6000PC

South America

## **COMBINED SOLUTION WITH LEASE ENGINE, REPAIRS, AND TESTING SAVES CUSTOMER MILLIONS**

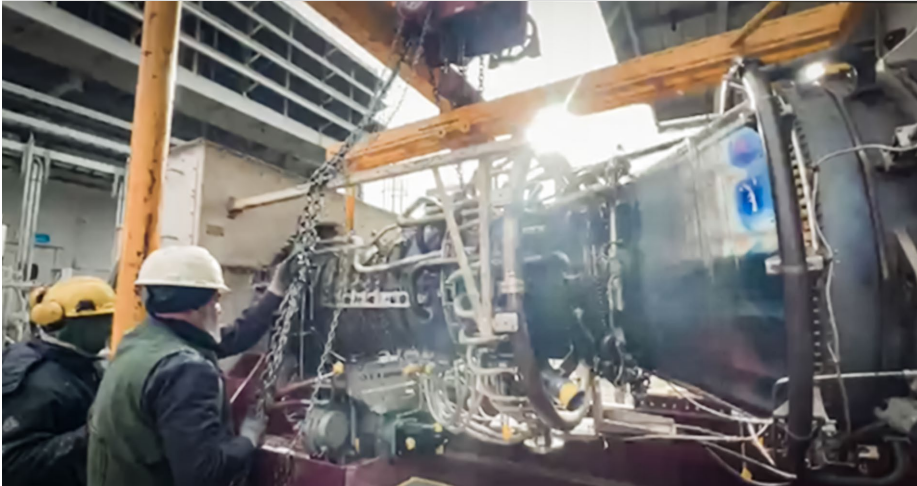
The Latin American Field Services team performs an engine exchange, swapping the PE6000 lease engine with the repaired unit.

PROENERGY dispatched Field Services team members in Latin America to the customer site for a complete review of the machine. The onsite investigation found that a high-pressure turbine (HPT) failure had caused downstream damage, including the low-pressure turbine (LPT), which necessitated major engine repairs at a PROENERGY depot.

The PROENERGY Aero Depot network coordinated services between the Level-IV depot in Houston and the world's only LM6000PC / PD string-test facility in Sedalia. Expert technicians immediately inducted the unit for disassembly, condition-based repairs, and reassembly.

After Aero Depot technicians reconditioned the unit, an engine test confirmed power output and heat rate. Once complete, the Latin America and US Field Services teams communicated with Engineering to reinstall and commission the unit.
