FIELD SERVICES, AEROADVANTAGE SERVICES, AND LEASE ENGINE

2X LM6000PC

COMBINED SOLUTION WITH LEASE ENGINE, REPAIRS, AND TESTING SAVES CUSTOMER MILLIONS

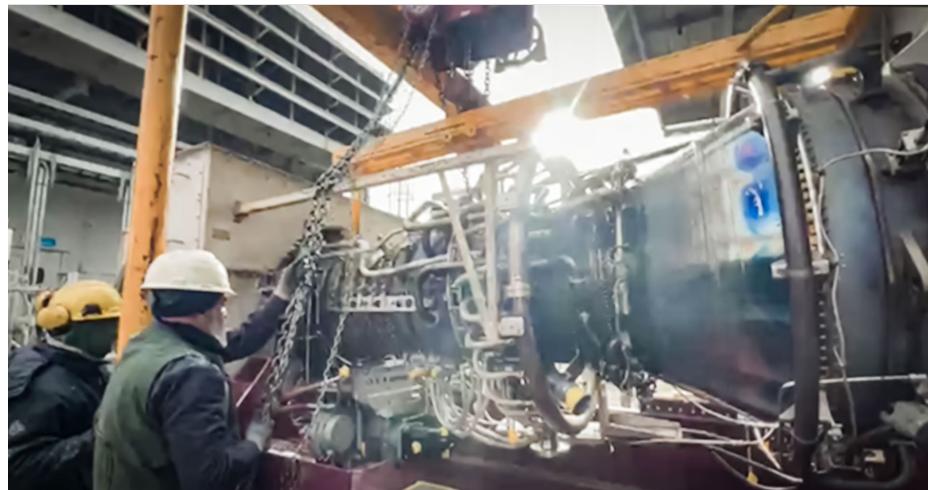
The Latin American Field Services team performs an engine exchange, swapping the PE6000 lease engine with the repaired unit.

PROENERGY dispatched Field Services team members in Latin America to the customer site for a complete review of the machine. The onsite investigation found that a high-pressure turbine (HPT) failure had caused downstream damage, including the low-pressure turbine (LPT), which necessitated major engine repairs at a PROENERGY depot.

The PROENERGY Aero Depot network coordinated services between the Level-IV depot in Houston and the world's only independent LM6000PC/PD string-test facility in Sedalia. Expert technicians immediately inducted the unit for disassembly, condition-based repairs, and reassembly.

After Aero Depot technicians reconditioned the unit, an engine test confirmed power output and heat rate. Once complete, the Latin America and US Field Services teams communicated with Engineering to reinstall and commission the unit.
